November 15, 2022

BEL 220074

Re: Arborist Report and Tree Saving Plan – The Enclave, Fort Erie

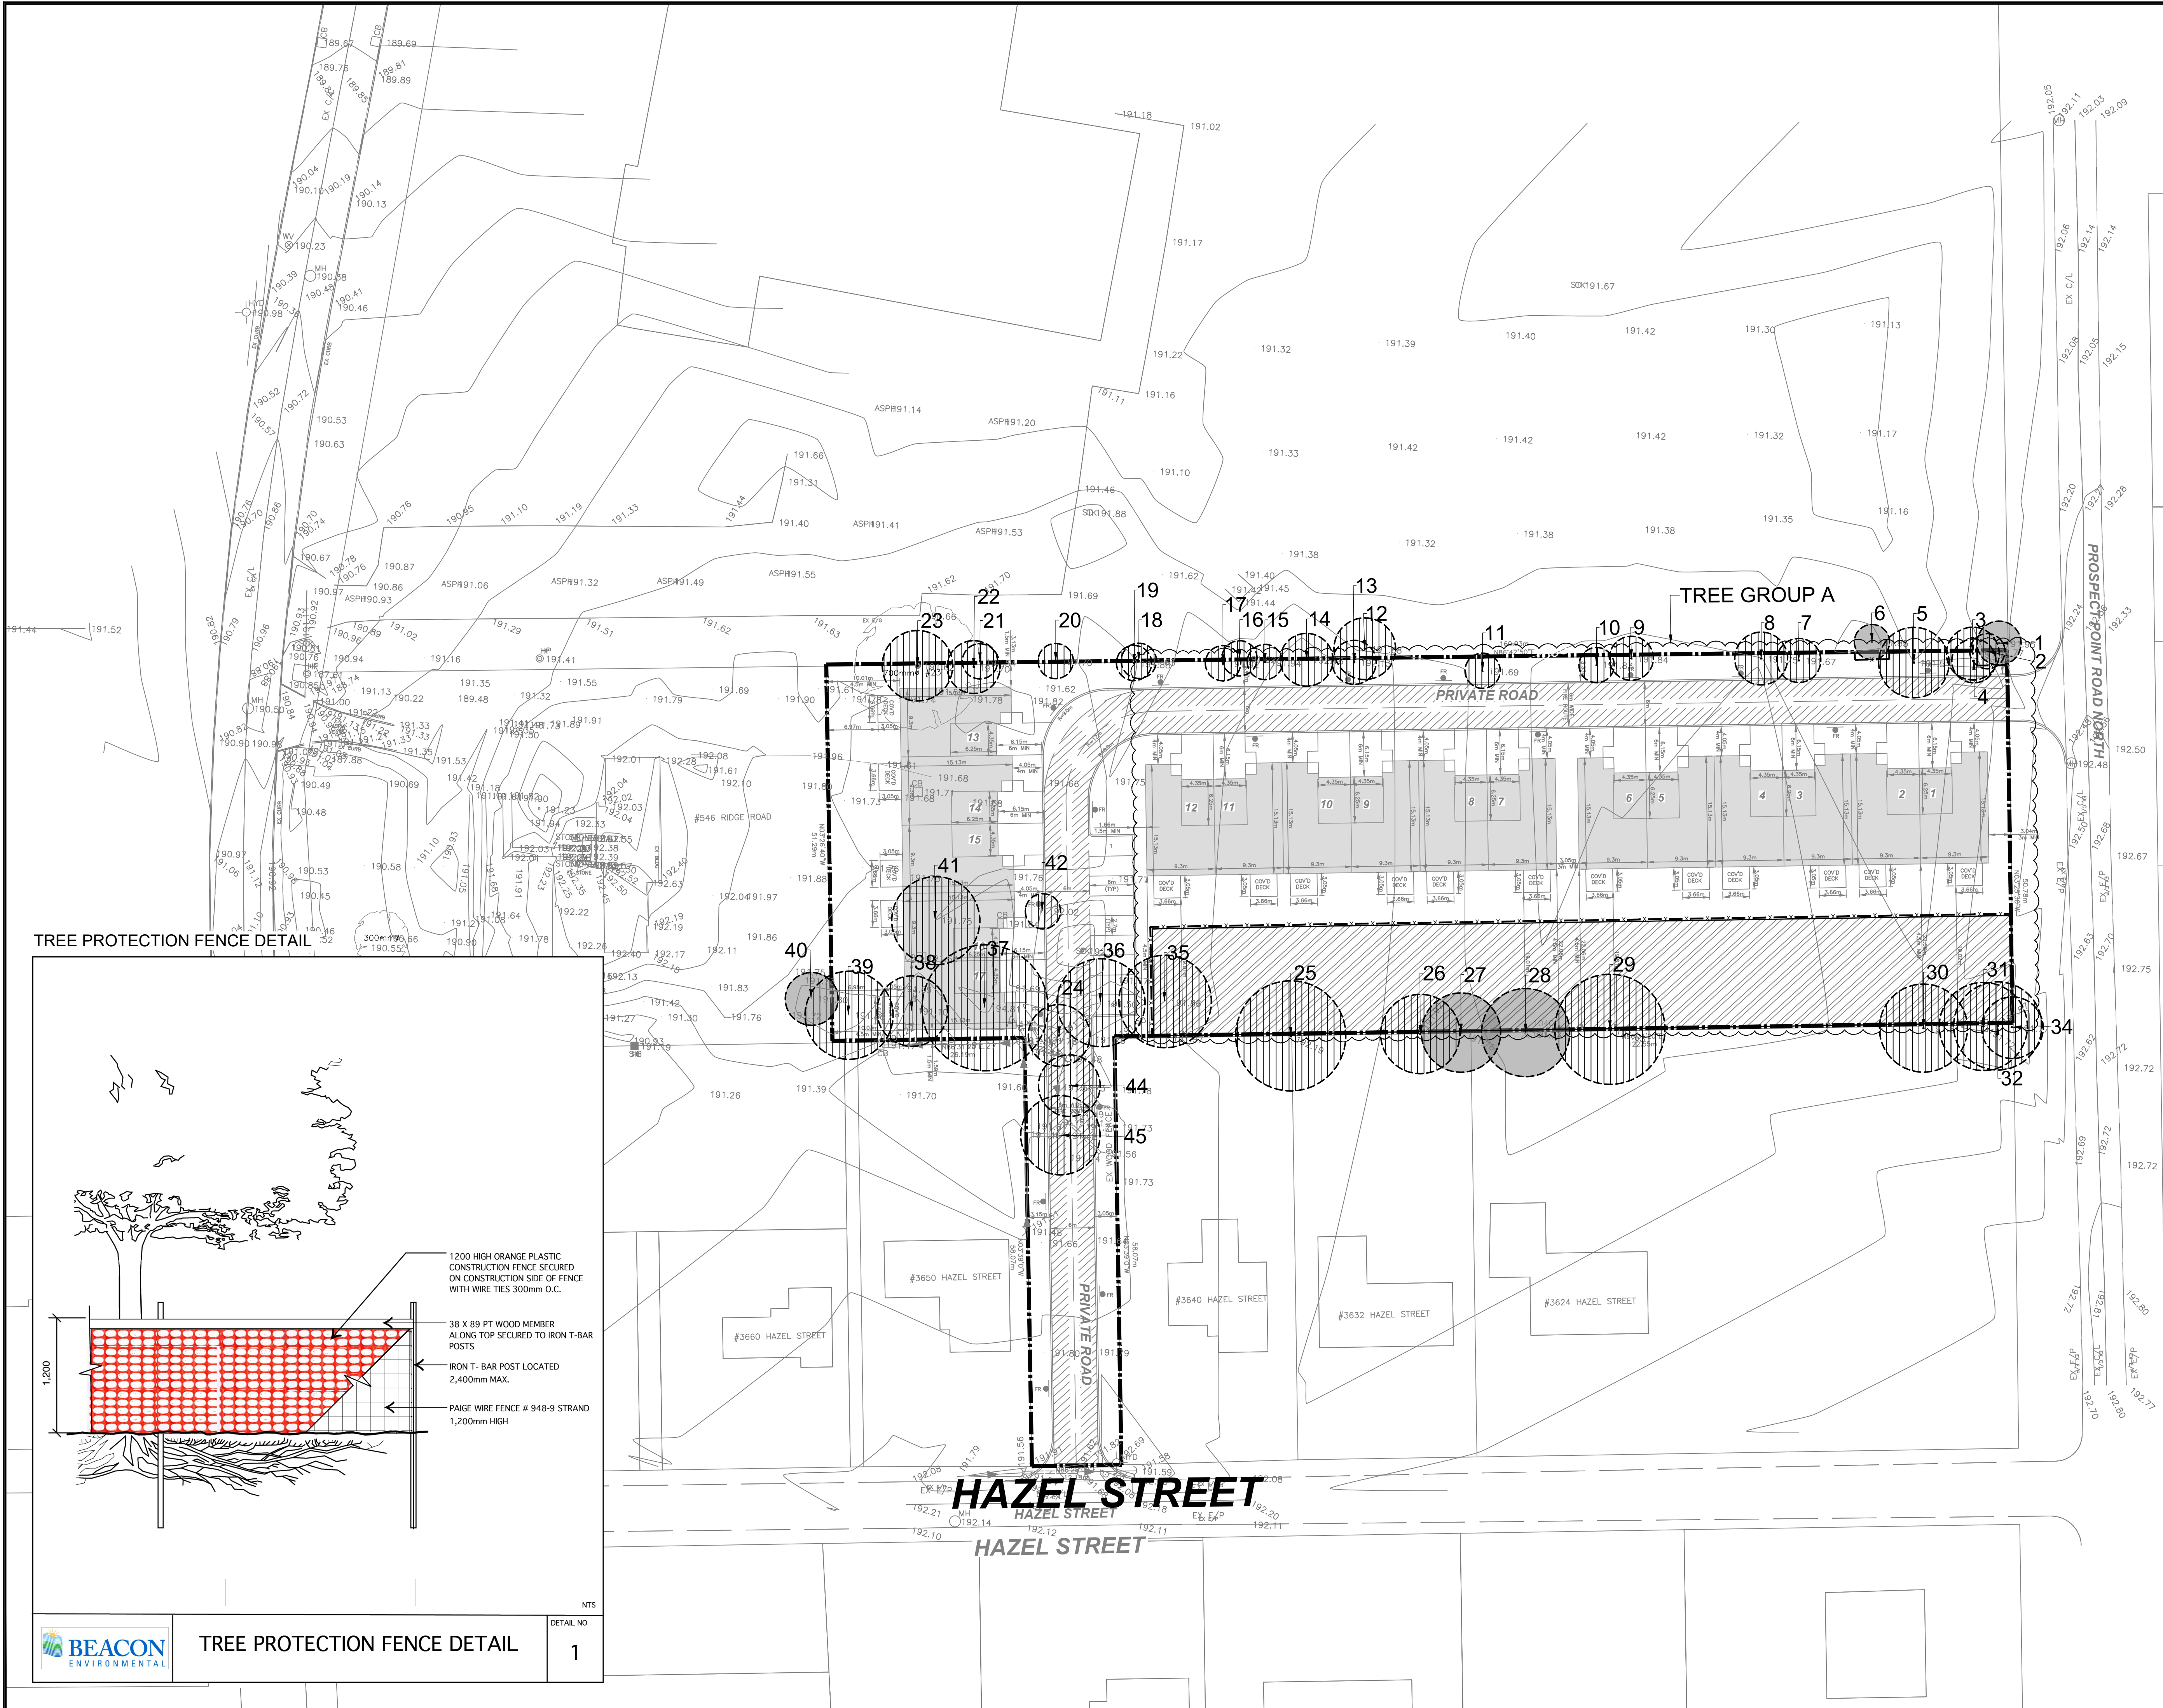
SHEET TITLE	
TREE INVENTORY AND PRESERVATION PLAN	
PROJECT Nº:	220074
DRAWN BY:	NC
CHECKED BY:	DW
DATE:	03 November 2022
FIGURE Nº:	TP-1

Of the 196 trees identified within the woodland (Group A), the majority are in fair or good condition and 14 were assessed to be in poor condition. Of the 43 individually tagged trees located along the property limits, 18 were determined to be in poor health and/or exhibited poor form/structural defects (see **Figure TP-1**).

Based on a review of the proposed development and our understanding of the general grading requirements, the majority of trees from Tree Group A will require removal. Approximately 65% of tree Group A is impacted by development; therefore, it is estimated that 126 tree will be removed.

Of the 43 individual trees that were inventoried, 31 are identified for removal to accommodate the proposed development. Of these, four (4) are dead and six are in poor health or structural condition. An additional seven (7) trees along the southern property boundary are also recommended for removal due to poor condition or significant structural defects.

An approximately 0.25 ha portion of tree Group A has been identified as tree preservation area (see **Figure TP-1**). Aside from trees located along the southern property line, a detailed tree inventory has not been completed for this area. Given that this area is approximately 35% of tree Group A, it is estimated that it contains 70 trees to preservation.

Outside of the tree protection area, three trees located along the property lines have been identified for preserving ((Tree 1, 6, and 40).

A detailed tree inventory of this area is recommended to determine if there are any additional potentially hazardous trees that require mitigation or removal.

Trees to be retained are to be protected through the establishment of a minimum tree protection zone (TPZ) as per **Table 1** and illustrated in **Figure TP-1**.

It is recommended that these trees be protected by installing tree protection hoarding at the limit of the TPZ as illustrated in **Figure TP-1**. Recommended hoarding consists of 1.2 m high plastic mesh affixed to paige wire fencing supported by metal t-bar posts spaced a minimum of 2.4 m apart, with a top 2x4 wood rail for additional support as illustrated in **Figure TP-1**. Erosion and sediment control fencing (silt fence) fitted with orange mesh fencing may double as tree protection fencing.
