Tree Inventory and Preservation Plan Report

272 Ridge Road
Fort Erie, ON

8 June 2022

Jackson Arboriculture Inc. Project No. P312

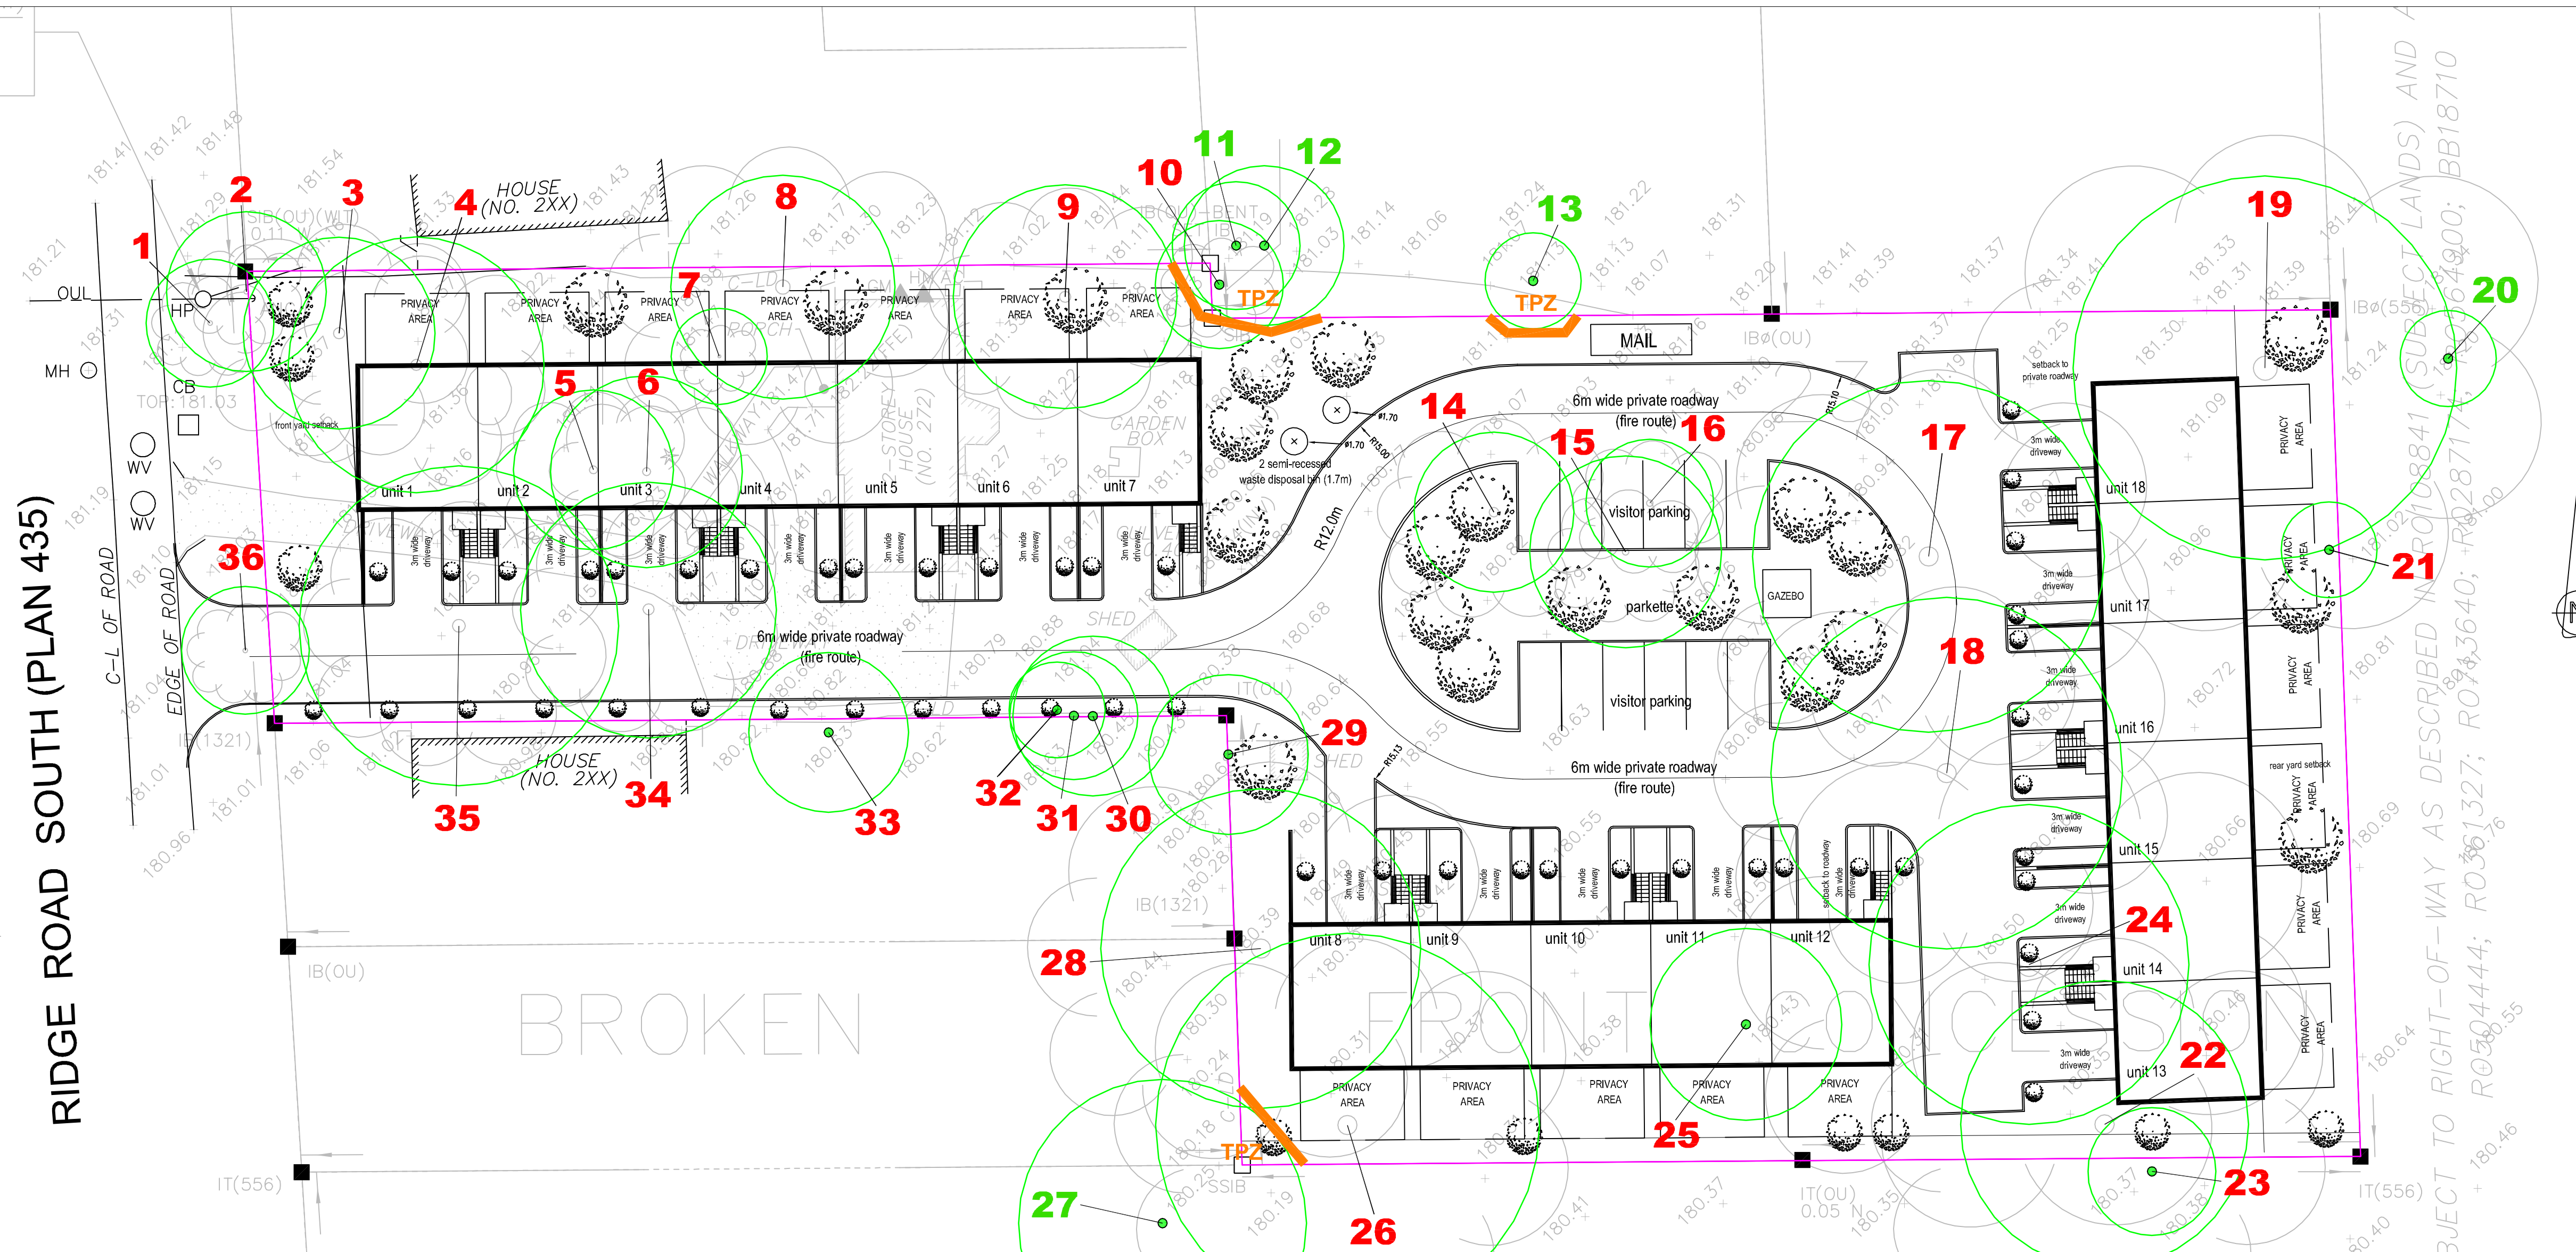
Sheet # 1

The removal of Trees 1-10, 14-19, 21-26 and 28-36 will be required to accommodate the proposed development.

Trees 10, 23, 29-31 and 33 appear to reside partially or fully on neighbouring property. Permission from the respective property owners will be required prior to the removal of trees residing partially or fully on neighbouring property.

Trees 1, 2 and 36 appear to reside in the municipal road allowances. Permission from the appropriate Town department will be required prior to their removal.

The preservation of Trees 11-13, 20 and 27 will be possible with the use of appropriate tree protection measures. Tree protection fence must be installed prior to the commencement of demolition to ensure that the trees identified for preservation are not impacted by the proposed development. Refer to Sheet 1 for the prescribed tree protection fence locations and the tree protection fencing detail.

- Tree protection fence must be installed at the locations outlined on Sheet 1 prior to the commencement of demolition.
- Once tree protection fence has been installed it must not be moved, relocated or altered in any way (unless repairing fallen fence etc.) for the duration of the construction period.

- No intrusion into an area identified on Sheet 1 as a tree preservation zone (TPZ) is allowed at anytime during construction unless noted otherwise in this report and on Sheet 1.

- No storage of machinery, construction debris, materials, waste or any other items is allowed within a TPZ.
- Any tree branches and roots that conflict with the proposed development must be pruned by a Certified Arborist in accordance with good arboricultural practice.

- Tree protection fencing should be inspected by a Certified Arborist prior to and during construction to ensure that the fencing remains intact and in good repair throughout the stages of development.
