**Tree Impact Analysis Report  
3303 Dominion Road  
Fort Erie, Ontario**

21 July 2023

KUNTZ FORESTRY CONSULTING INC. Project P3866

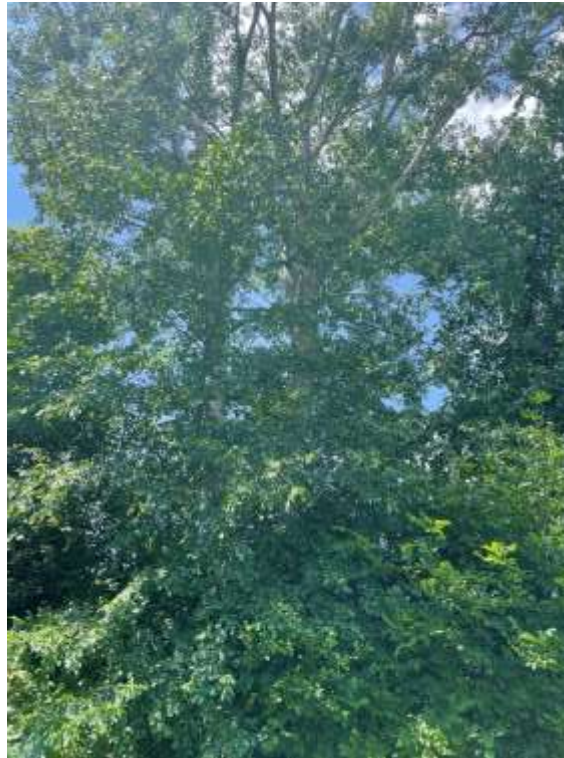
Image 8. Tree 1380

Encroachment into the mTPZs of Trees 1380, M – O, Q, R, and T – V will be required to accommodate the proposed development. Encroachment into the mTPZ of Tree 1380 will be required to accommodate the overdig required for the construction of the proposed townhomes and the construction of a proposed covered terrace. Encroachment into the mTPZs of Trees M – O, Q, R, and T – V will be required to accommodate the construction of the proposed surface parking area proximate to the south property boundary. If the following mitigation measures are employed, long-term adverse effects are not anticipated for these trees.

1. Tree preservation fencing should be installed, as depicted on Figure 1, and maintained throughout the duration of the construction process.
2. Air-spade or low-pressure hydro-vacuum technology should be used to excavate trenches, in the locations indicated on Figure 1, under the supervision of a Certified Arborist.

- a. The depth of the portions of the trench adjacent to the proposed townhome will be a minimum of 90cm.
  - b. The depth of the portions of the trench adjacent to the proposed covered terrace will depend on the depth of excavation required to install the covered terrace.

3. Any roots exposed within the trenches are to be pruned by a Certified Arborist in accordance with Good Arboricultural Standards.
4. The trenches are to be backfilled with clean topsoil.

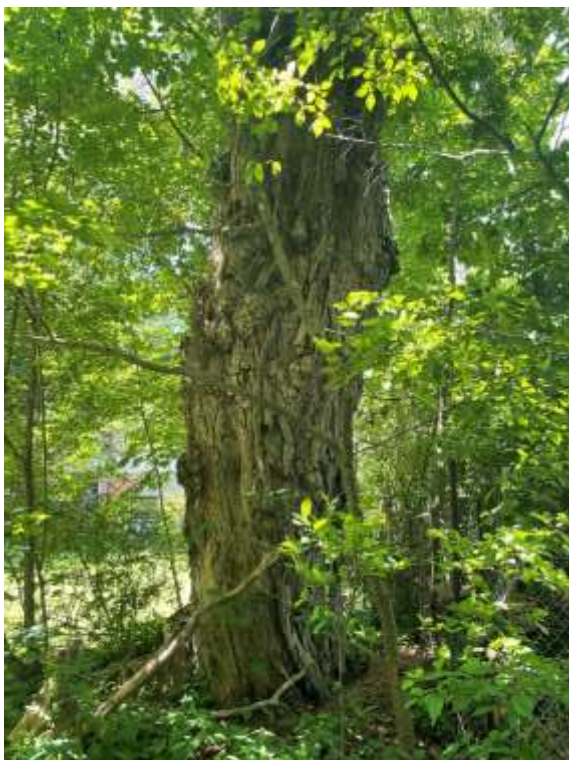
Image 10. Tree K

K	Willow species	<i>Salix sp.</i>	~160	-	P	P	P		4.0	9.6	Decay (H) in trunk, main leader lost, very large cavity at breaking point, only epicormic branching / coppice growth remains	Neighbour	Preserve
L	Red Maple	<i>Acer rubrum</i>	~26, 22, 16, 16	~41	F	FG	G		6.0	3.0	V-unions at base and 0.2m with included bark	Neighbour	Preserve
M	Norway Maple	<i>Acer platanoides</i>	~110	-	PF	F	PF	20	10.0	6.6	Decay (M) in trunk, poor branch unions, broken branches (M)	Neighbour	Preserve - Conditional (Injure)
N	White Spruce	<i>Picea glauca</i>	~42	-	G	G	FG		4.0	3.0		Neighbour	Preserve - Conditional (Injure)

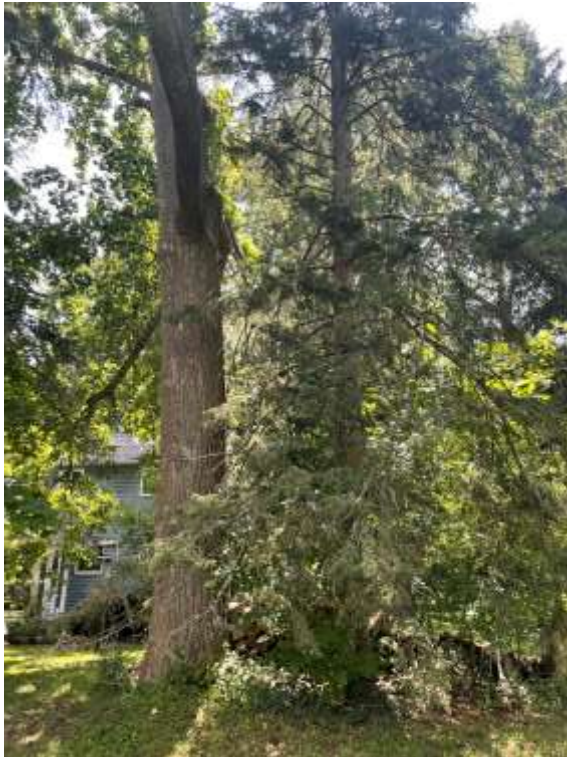
Image 13. Trees N (right) and O (left)

O	Tulip-tree	<i>Liriodendron tulipifera</i>	-96	-	G	F	F	20	10.0	6.0	Broken branches (M)	Neighbour	Preserve - Conditional (Injure)
P	Norway Maple	<i>Acer platanoides</i>	-16, 14	-21.5	FG	FG	FG		6.0	1.8	Union at base, one leader leaning (L)	Neighbour	Preserve
Q	Norway Spruce	<i>Picea abies</i>	-66	-	G	G	FG		7.0	4.2		Neighbour	Preserve - Conditional (Injure)
R	Norway Spruce	<i>Picea abies</i>	-44	-	G	G	G		5.0	3.0		Neighbour	Preserve - Conditional (Injure)
S	Basswood	<i>Tilia americana</i>	-16, 14, 10	-23.5	F	FG	FG		4.0	1.8	V-union at 0.1m with included bark	Neighbour	Preserve
T	Norway Spruce	<i>Picea abies</i>	-48	-	G	FG	F	10	6.0	3.0		Neighbour	Preserve - Conditional (Injure)
U	Norway Maple	<i>Acer platanoides</i>	-32, 28	-42.5	F	FG	F	10	5.0	3.0	Lean (L), v-union at 1m with included bark	Neighbour	Preserve - Conditional (Injure)
V	Black Walnut	<i>Juglans nigra</i>	-26	-	G	FG	FG		5.0	1.8	Vine competition (L)	Neighbour	Preserve - Conditional (Injure)

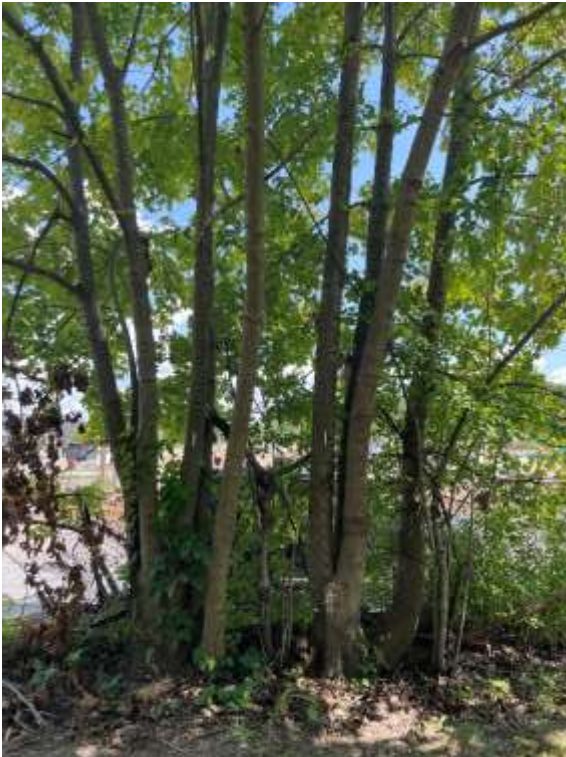
Image 19. Trees 1381 (right) and 1382 (left)

The removal of two trees, identified as Trees 1381 and 1382, will be required in order to fully remove the remnants of an existing chain link fence located along the property boundary. These trees are considered shared as they are located along the boundary between the subject property and the neighbouring property to the east (0 Dominion Road). As such, written permission from the neighbouring property owner is required prior to the removal of these trees.
