UPDATE TO PHASE I ENVIRONMENTAL SITE ASSESSMENT
613 Helena Street, Fort Erie, Ontario

Project No. 2100394AG

**Re: Update to Phase I Environmental Site Assessment
613 Helena Street, Fort Erie, ON.**

PHASE II ENVIRONMENTAL SITE ASSESSMENT

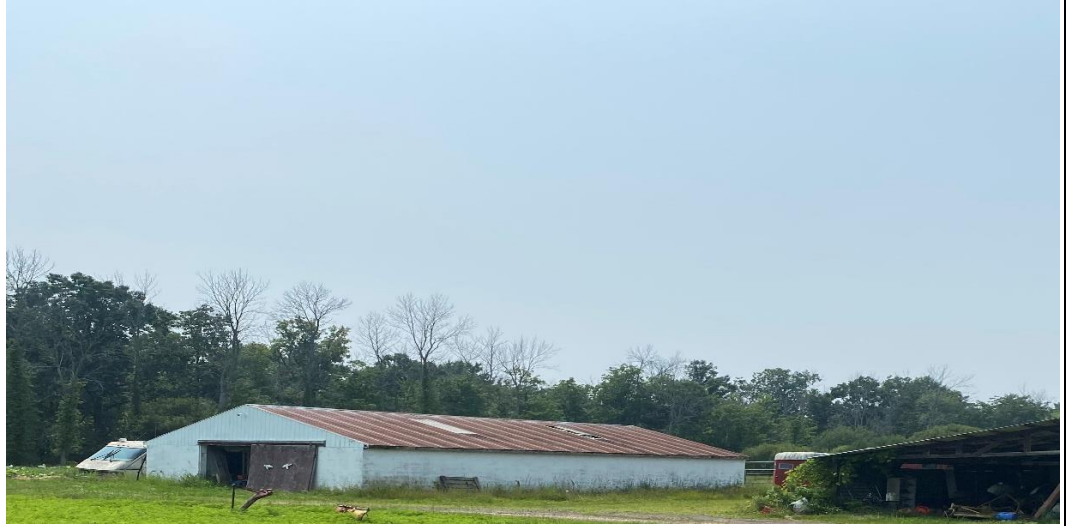
Photograph 5
South View

The only painted structures were the storage building south of the barn, the main residence, and the garage buildings. Given the age of construction of the site buildings (before 1934 and the mid-1970s to early 1990s), lead-containing paints (LCPs) may be present at the site, as the regulatory definition of LCP in Canada was recently updated (2010) to include a significantly lower allowable concentration of lead than was previously controlled. The external painted surfaces of the storage building, garage, and residential house were in acceptable physical condition (i.e., no peeling and/or flaking), according to observations made at the time of the site reconnaissance.

View of the storage building south of the barn on the Phase I Property.

Only by sampling and analyzing questionable paint samples can the presence of LCPs be validated. If LCPs are present at the Site, they can be handled by implementing proper management or abatement strategies to safeguard the health of those who work there, as mandated by the Occupational Safety and Health Administration (OHSA). LCPs may be encapsulated or removed if they are in poor condition (e.g., peeling or flaking) and present a threat to humans.

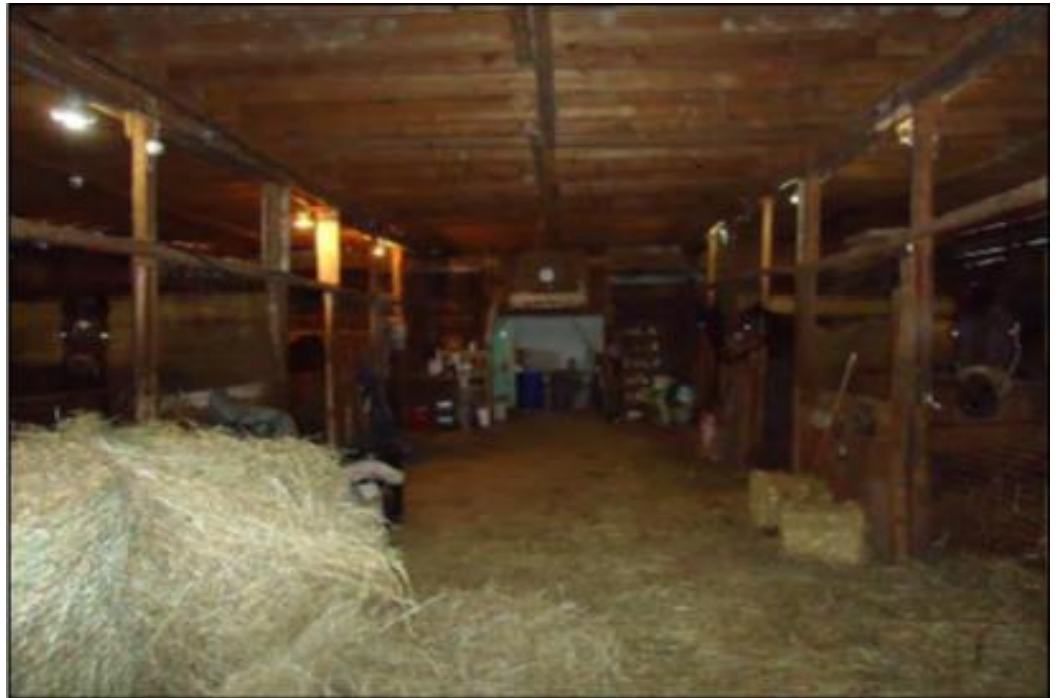
Photograph 6

Except for the barn, the site appeared to be well-kept in general. Leaks and water damage from exposed wood were discovered in the barn, which is typical of this sort of structure. The storage space connected to the barn to the south, where a tractor, lawnmower, and other agricultural type equipment, as well as jerry cans of gasoline, were observed. Significant petroleum/diesel odour was noticed. Some staining was observed under the tractor. The floor of the storage area was made up of wood planks and an open ground

View of the interior of the barn facing west.

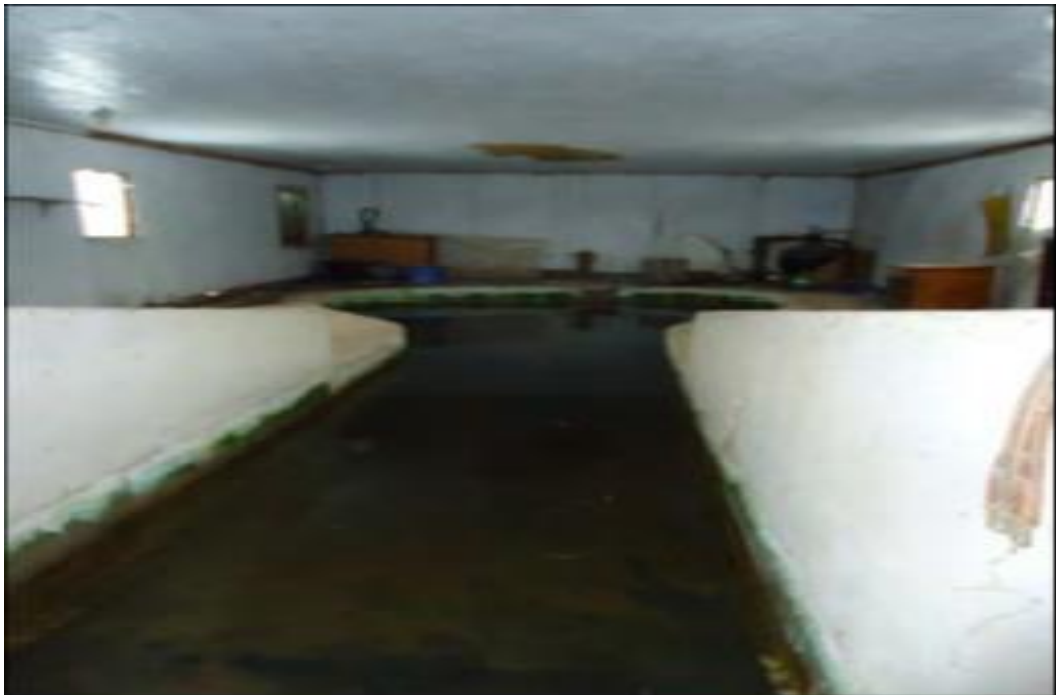
Photograph 8

Incandescent lights were used to light the barn. There was no heat or air conditioning in the barn. An inground concrete exercise pool for the horses was in the western wing of the barn.

View of the horse exercise pool in the west end of the barn facing west.

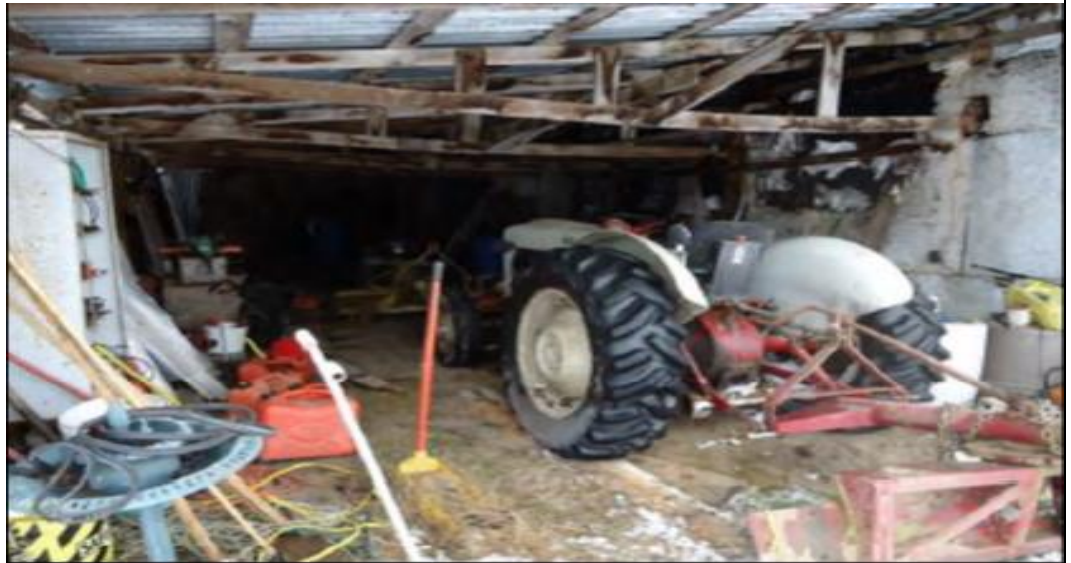
Photographs 9

The barn is located on the south side of the site, where several jerry cans of fuel were found in the storage space. In the same area, tractors, lawnmowers, other agricultural equipment are stored. Strong petroleum/diesel odours were also detected in this area. Some staining was also observed under the tractor.

View of storage area attached to the south side of the barn facing west on the Phase I Property.

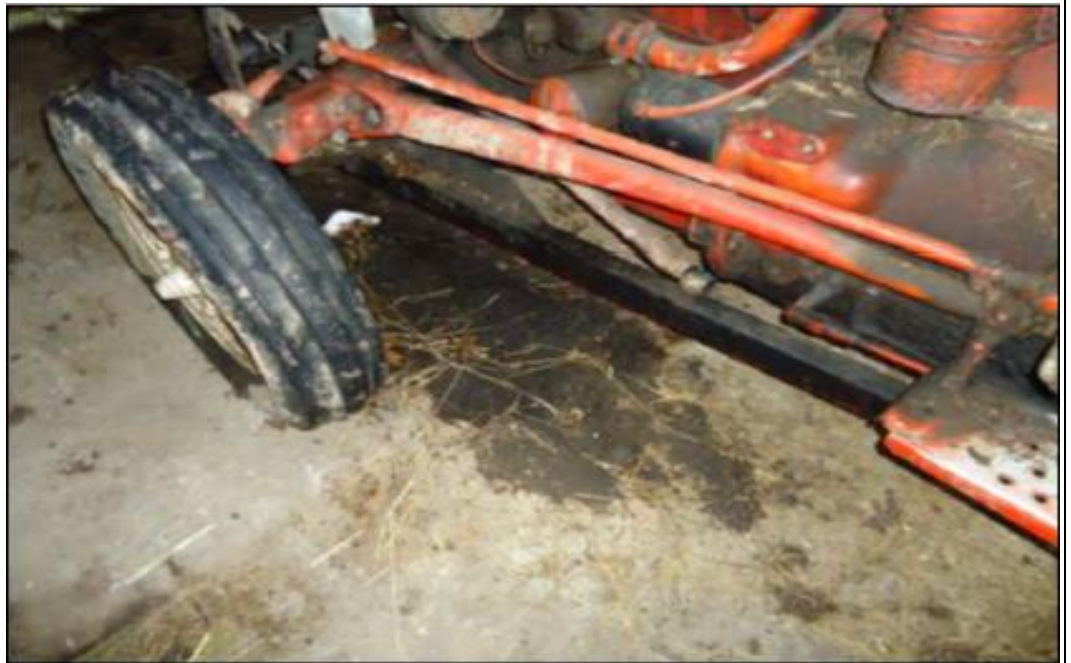
Photograph 10

Several jerry cans of fuel were observed in the barn's storage space on the south side. Strong petroleum/diesel odours were also detected in the area where a tractor, lawnmower, and other agricultural equipment were stored. Under the tractor, staining was also visible.

View of staining in the storage area attached to the south side of the barn facing northwest on the Phase I Property.

Recommendations	Based on the conclusions for the potential of contaminants entering the Phase I Property, it is recommended that a limited Phase II ESA be carried out.
Limitations	The Client may use the findings in this report for these purposes subject to the <i>Statement of Limitations</i> , which forms an integral part of this document. No other third parties are entitled to rely upon this report without the express written consent of HLV2K Engineering Limited. Any use, which a third party makes of this report, is the sole responsibility of the said third party; HLV2K Engineering Limited accepts no responsibility for any damages.

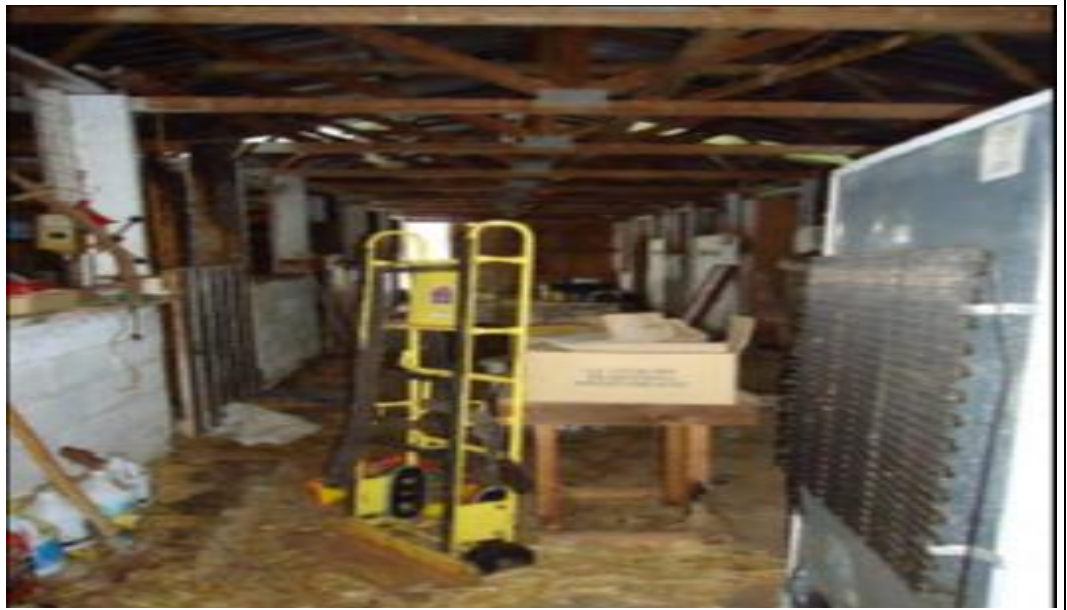
Photograph 11

View of interior of storage building south of the barn facing west on the Phase I Property.

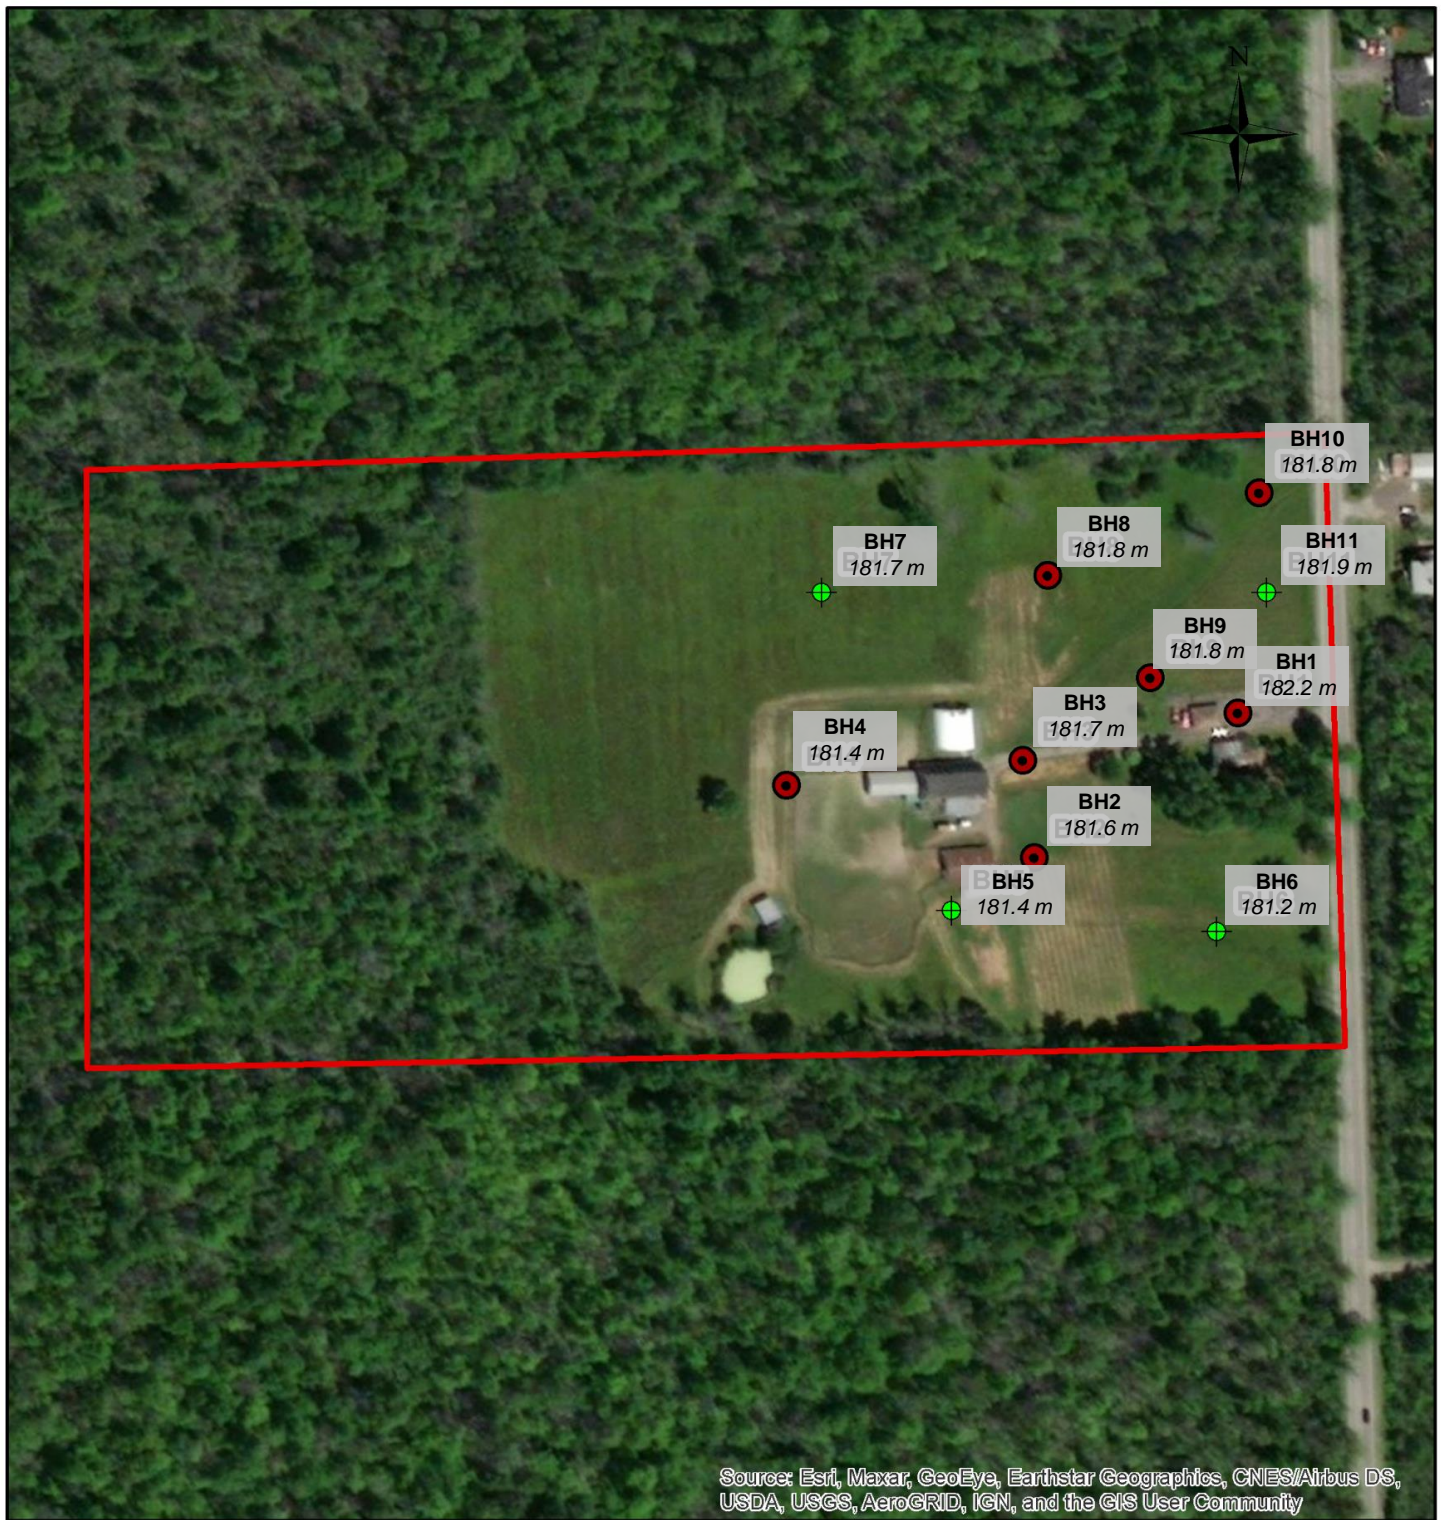
Drawing 2

- Approx. Site Boundary
- Borehole
- ⊕ Monitoring Well
- 181.4 Ground Surface Elevation (m asl)
