**Shayne Avenue**  
 Between Orchard Ave. & Evelyn Ave.  
 Ft. Erie, ON

**Bridge and Quarry Inc.**  
 18 Cabot Street, Welland, ON L3C 5W4

**Tree Preservation Plan**

Project # P295  
 Date 5 July 2022  
 Scale 1:750

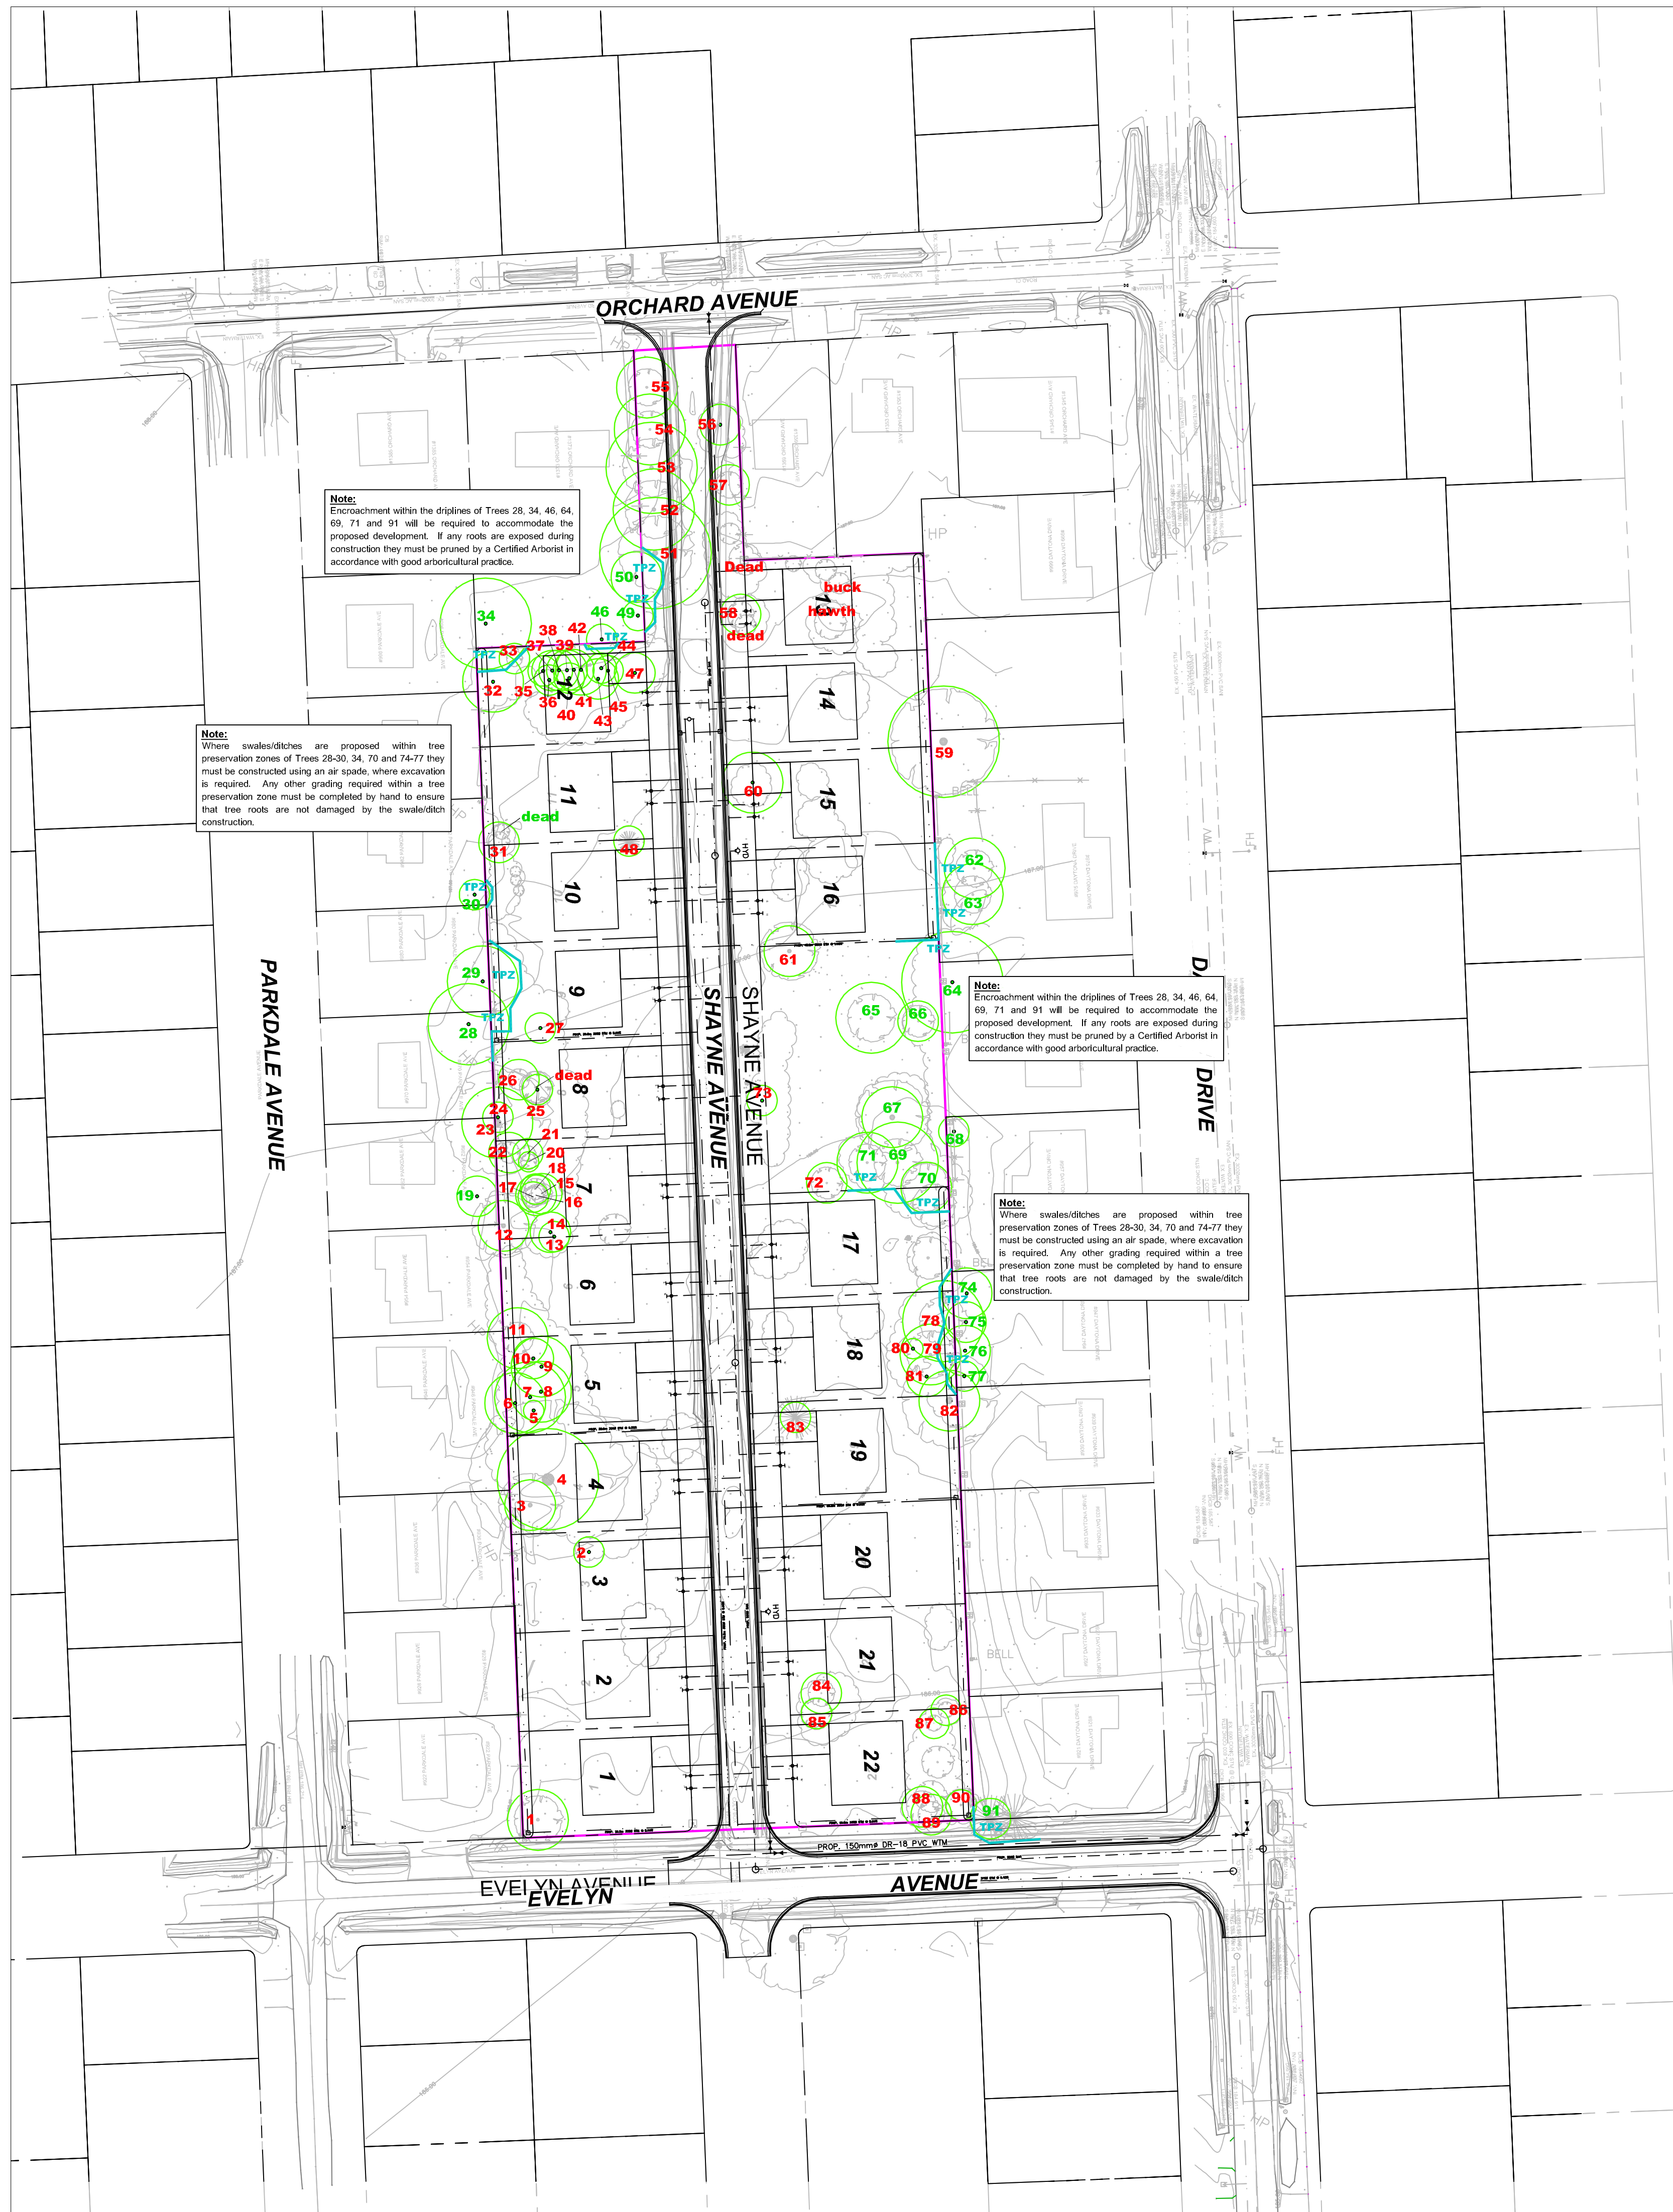
Figure # **1**

- Tree protection fence must be installed at the mTPZ distance and locations outlined in Table 1 and on Figure 1 prior to the commencement of demolition.

- No intrusion into an area identified on Figure 1 as a tree preservation zone (TPZ) is allowed at anytime during construction.
- No storage of machinery, construction debris, materials, waste or any other items is allowed within a TPZ.

- Once tree protection fence has been installed it must not be moved, relocated or altered in any way (unless repairing fallen fence etc.) for the duration of the construction period.

- Any tree branches (and roots) that conflict with proposed development must be pruned by a Certified Arborist in accordance with good arboricultural practice.

- Tree protection fencing should be inspected by a Certified Arborist prior to and during construction to ensure that the fencing remains intact and in good repair throughout the stages of development.
